VIBRATION-RESPONSE TESTS OF A  $\frac{1}{5}$ -SCALE MODEL

OF THE GRUMMAN F6F AIRPLANE IN THE  
LANGLEY 16-FOOT HIGH-SPEED TUNNEL

By Theodore Theodorsen and Arthur A. Regier

MR No. L4K18a

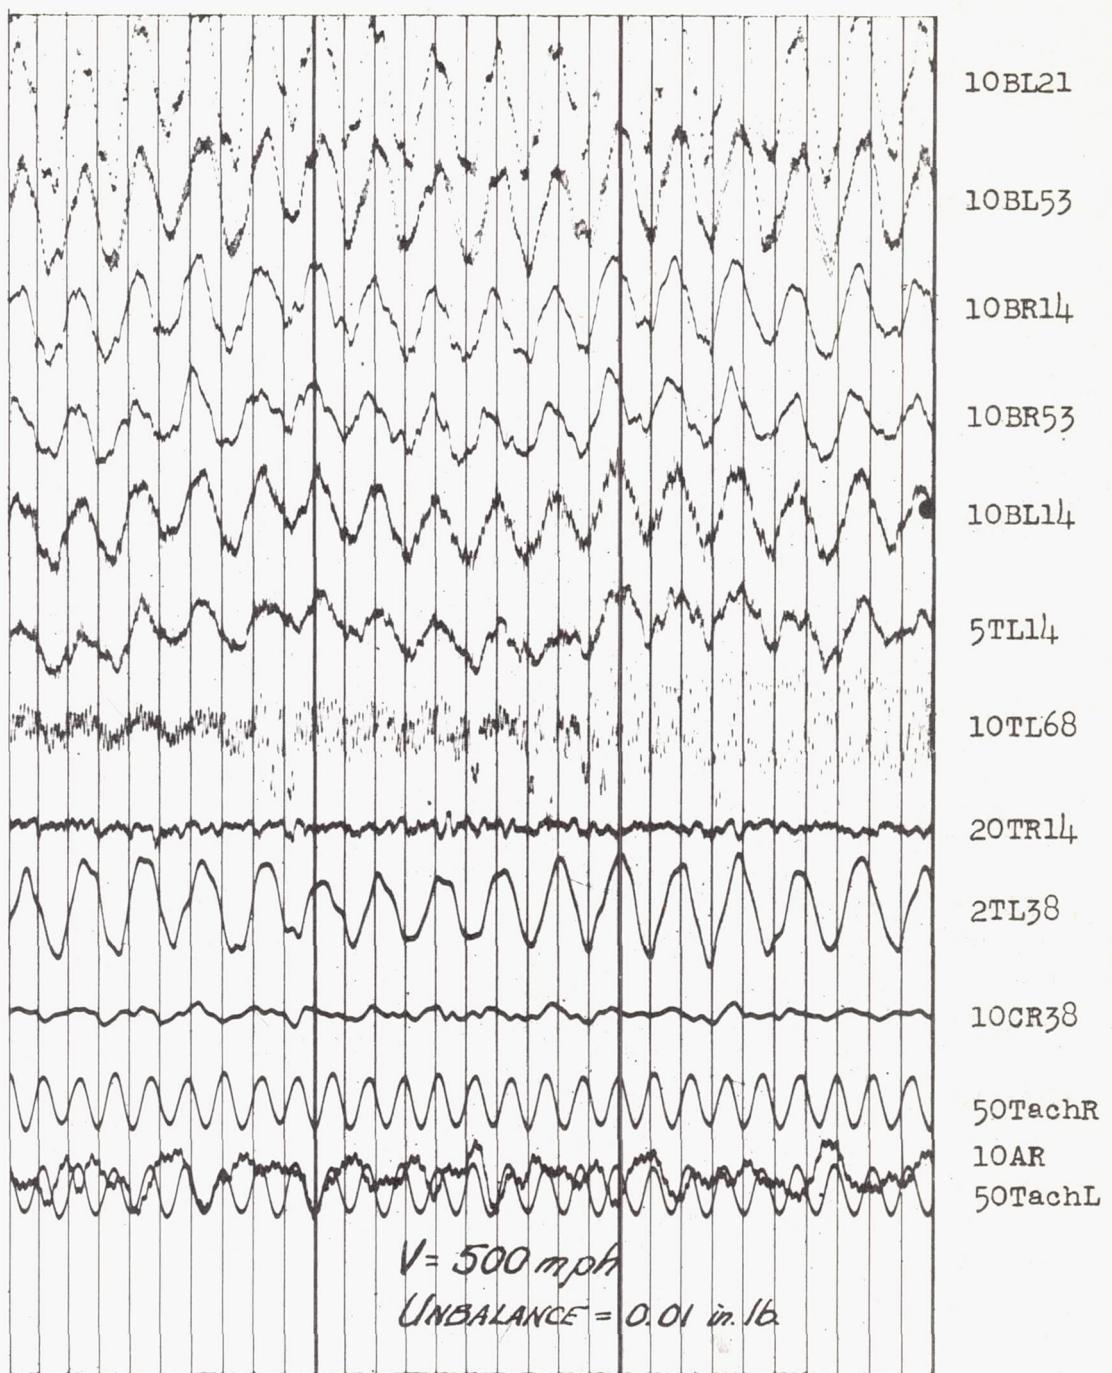
A sample of the records taken during the tests is given for 0, 250, and 400 miles per hour in figures 5 to 7. A record taken at about the time of failure is shown in figure 8. The responses in this case are not forced by the vibrator but are entirely dependent on the air stream. The number preceding the gage designation in these figures represents the attenuation of the amplifiers.

Figure 8.- Oscillograph record taken at about the time of failure of the model. Velocity, 500 miles per hour; (Symbols indicate attenuation and gage designation.)

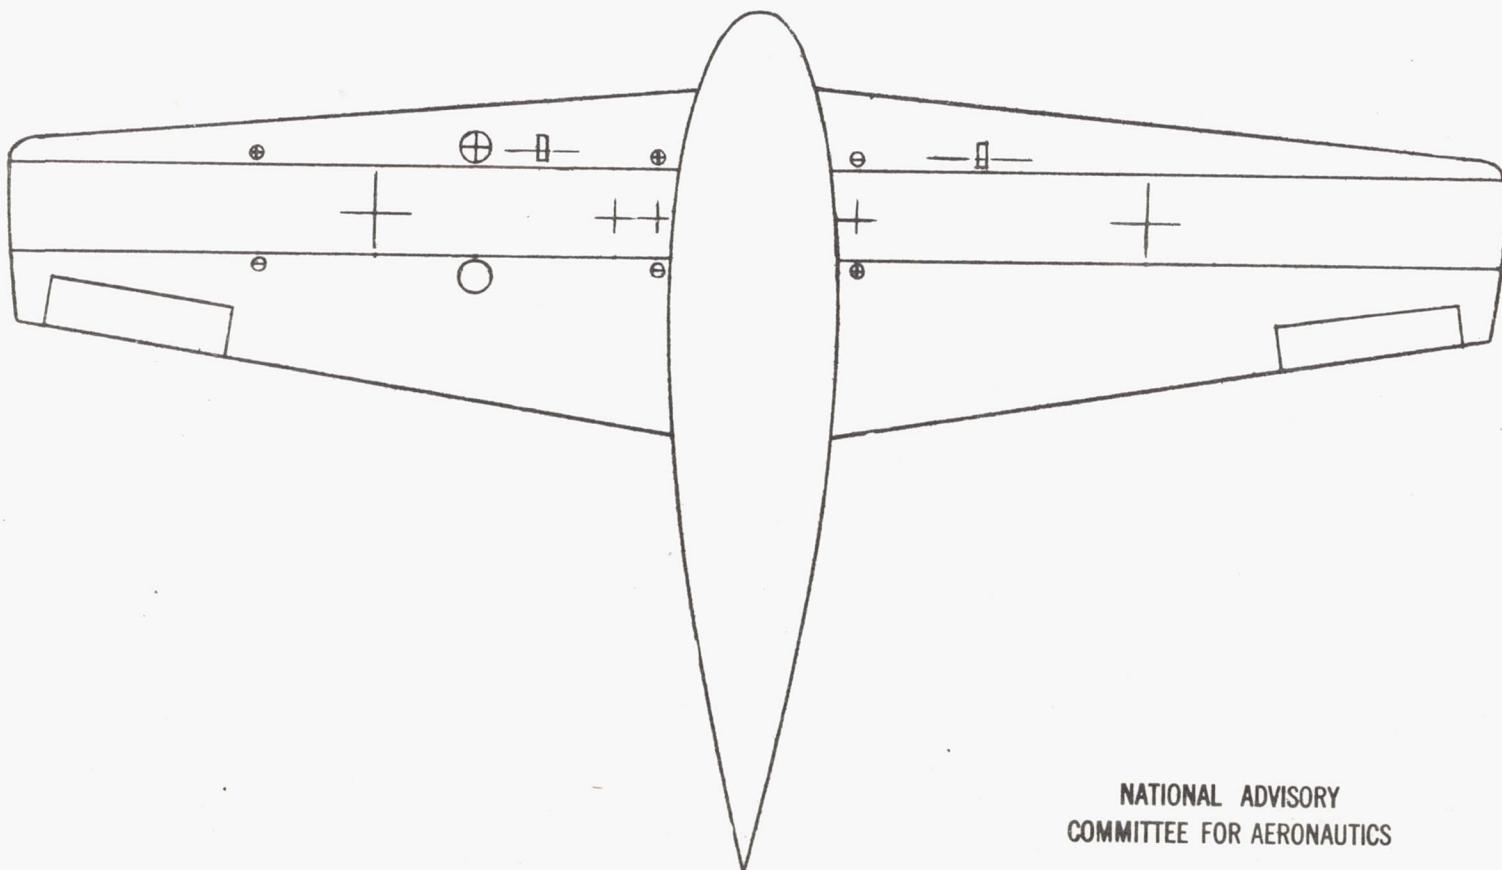
The mode of vibration at the various response peaks is indicated in figures 11 to 15. The mode of vibration at about the time of failure is given in figure 16. The relative sizes of the plus and minus signs in these figures indicate the order of magnitude of the strain. The signs for the bending gages are placed between the spars, and the torsion responses are indicated by the signs in the circles. The following convention has been adopted for the bending- and torsion-gage signs: A plus sign on the front spar indicates torsion in a downward direction at the leading edge and a plus sign on the bending gage indicates deflection of the wing in a downward direction.

Figure 16.- Mode of vibration for 500 miles per hour at failure  
of model. Frequency, 50 cycles per second.

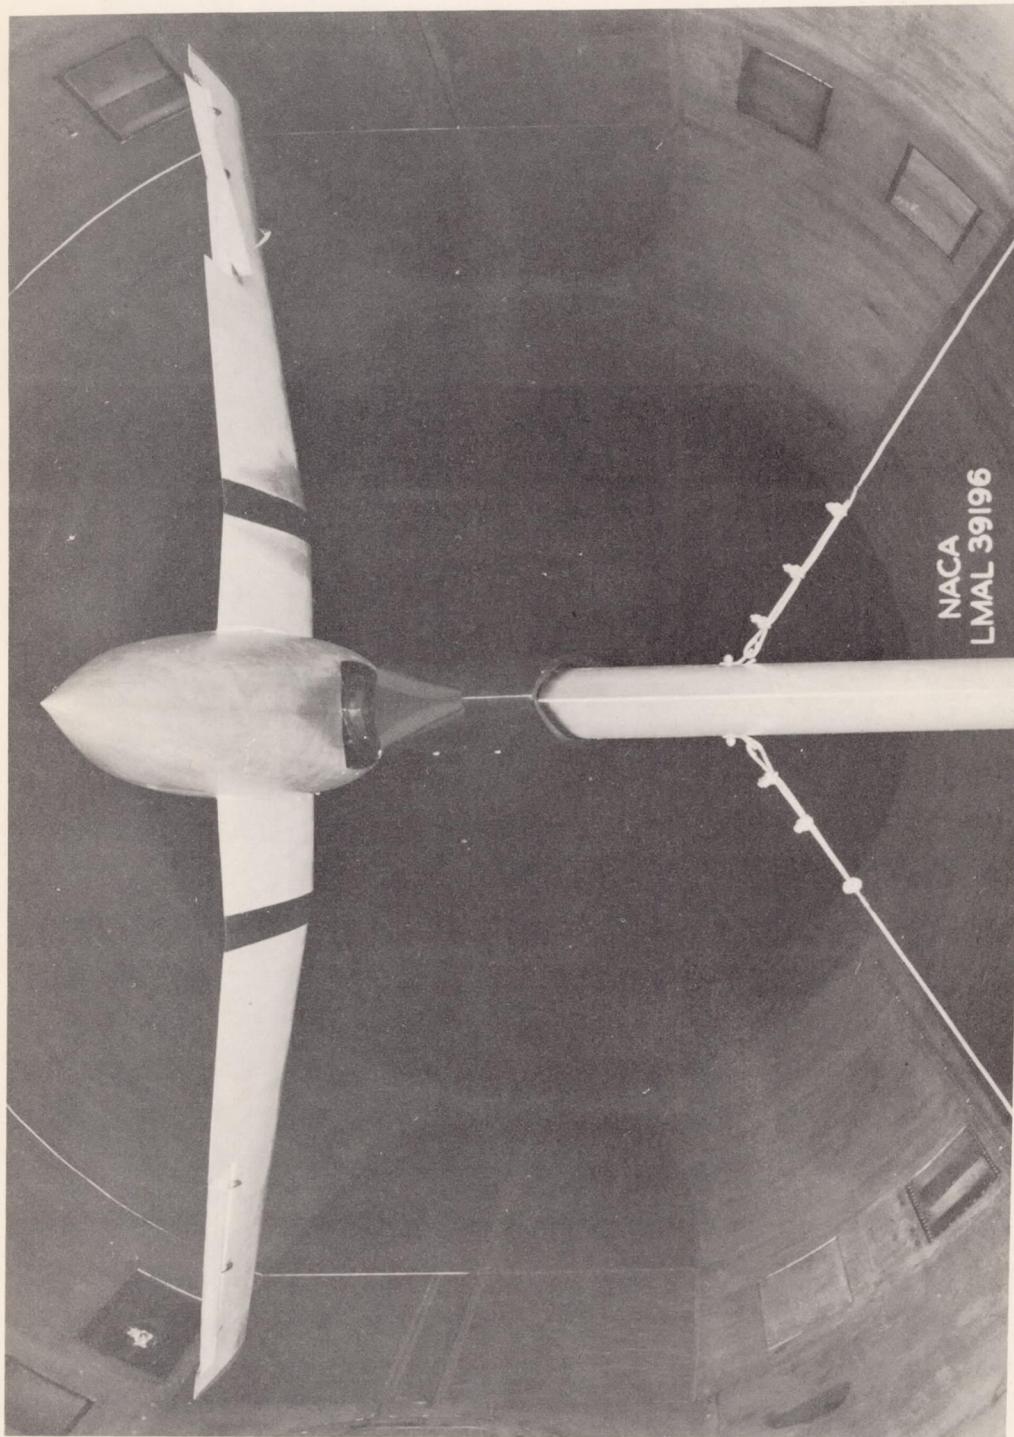
(a) Over-all view.

At 500 miles per hour a large response occurred at about 50 cycles per second, which blanketed any response from the vibrators. The tests were stopped because of failure of the soldered joints in the aileron supports. Photographs of the model taken after the failure are shown in figure 17.

Figure 17.- Model after failure.

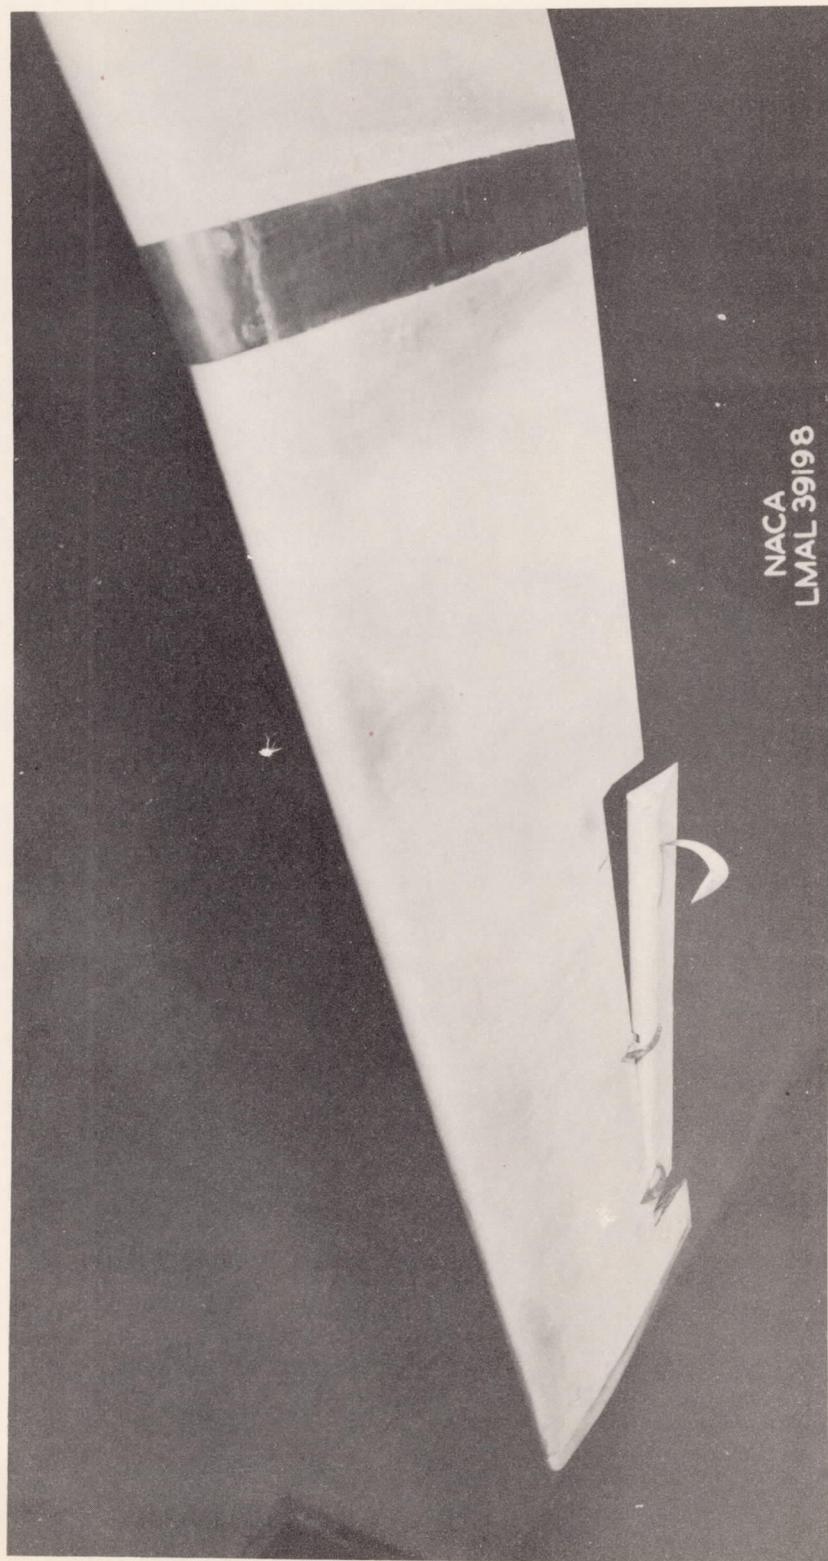
(b) Right wing.

Figure 17.- Model after failure. Continued.

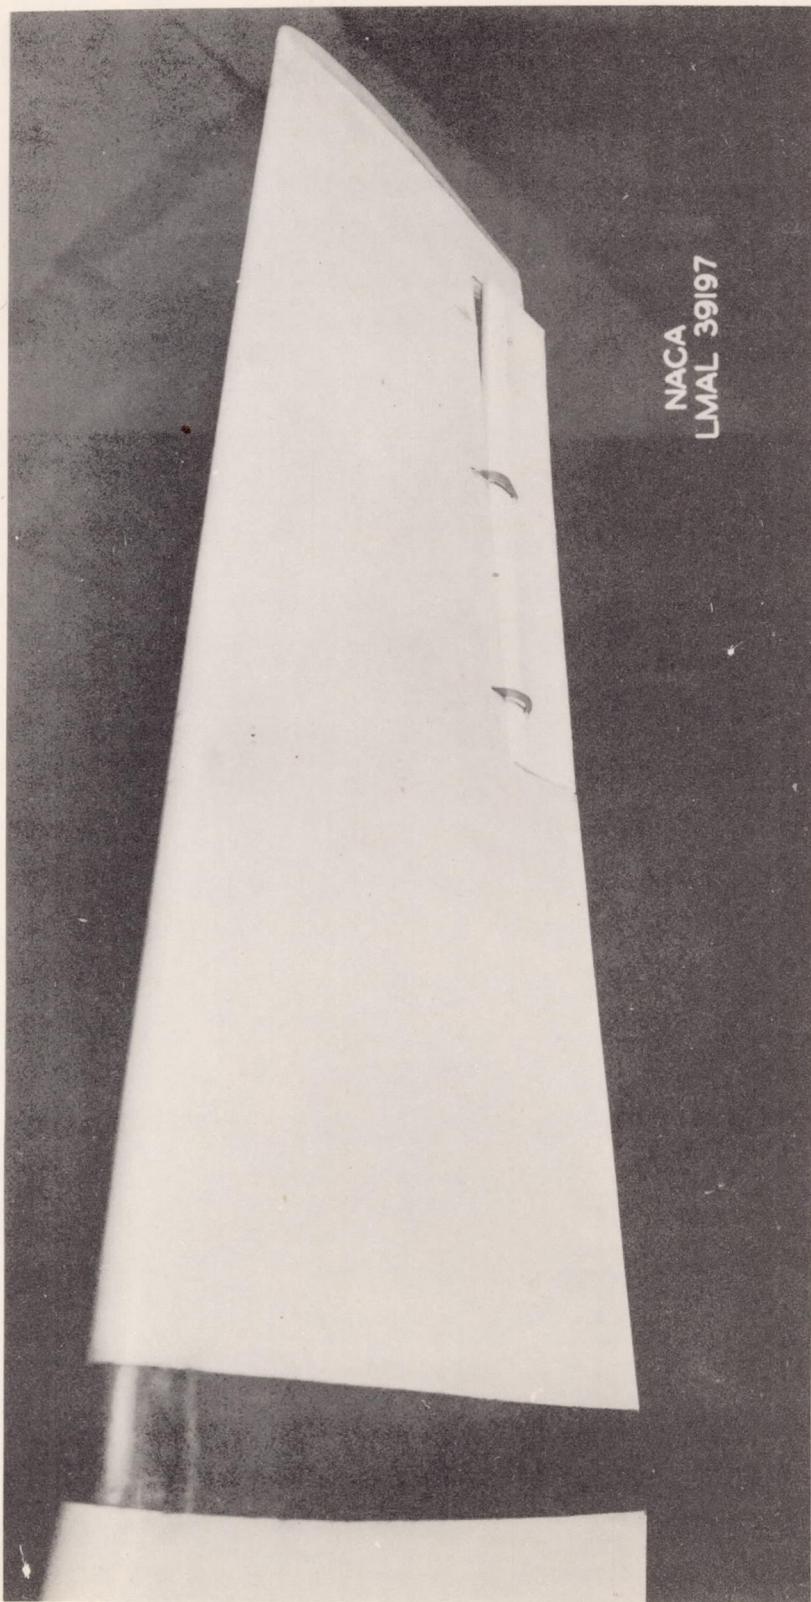
(c) Left wing.

Figure 17.- Model after failure. Continued.

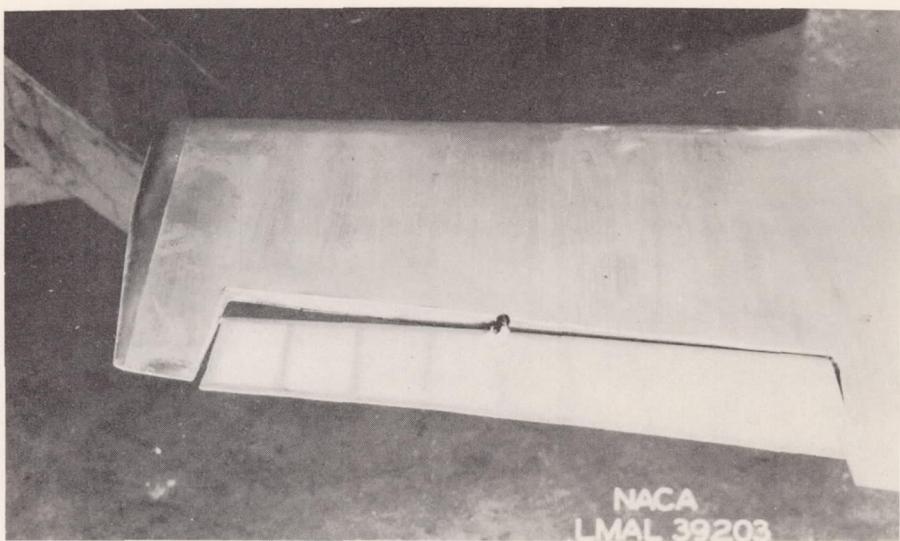
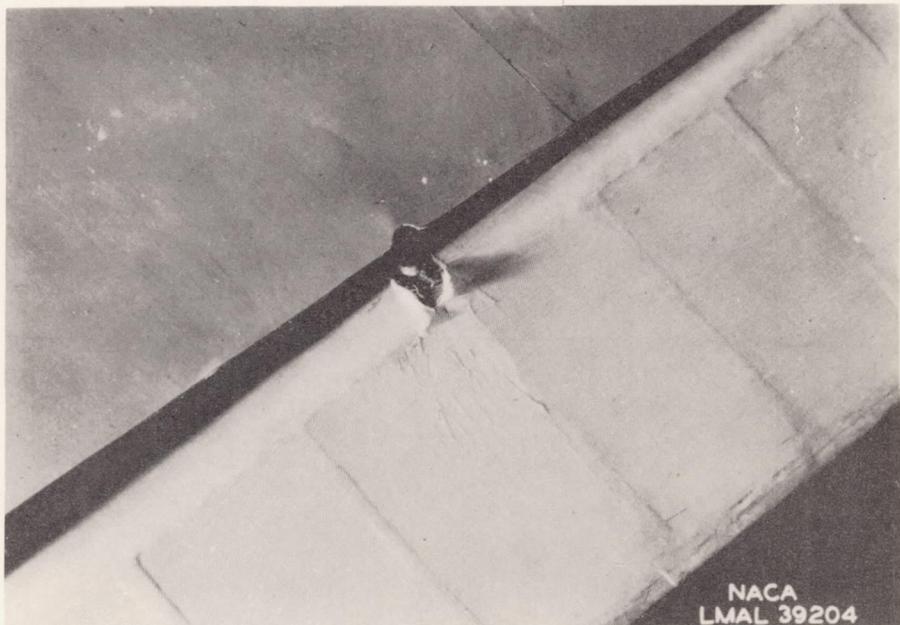
(d) Aileron.

Figure 17.- Model after failure. Concluded.
